AN 382 Quantitative Damage Profiles By Ion Channeling

May 7, 2007 (Version 4.0)

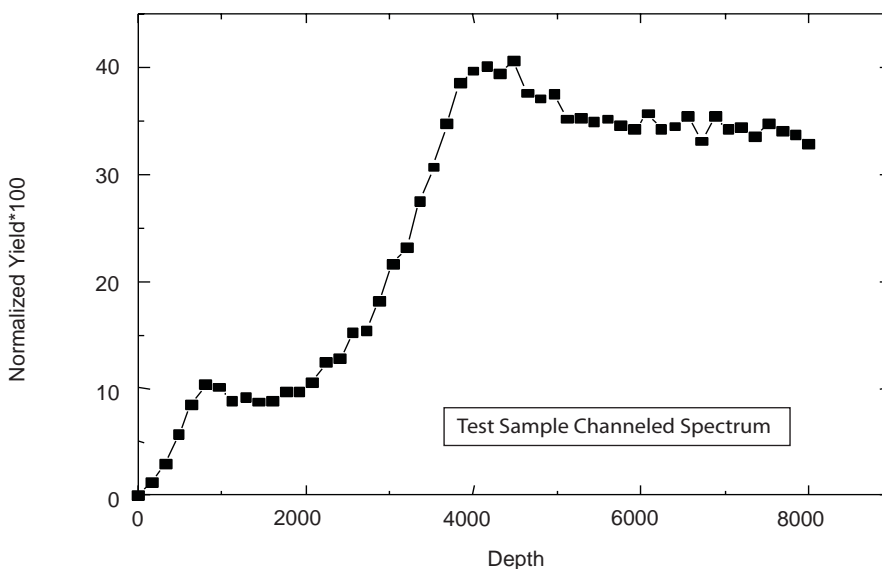
Figure 1. Channeling Yield Raw Data

Figure 1 shows the channeling yield raw data plotted versus depth from a Si sample implanted with $1E14$ atoms/cm² of P. The extracted quantitative damage profile is shown in Figure 2. For comparison the simulated damage profile obtained from a TRIM simulation is shown in Figure 3. The TRIM damage profile shows the total damage (displacement) for all atoms in an amorphous Si sample. The sample shown in Figures 1 and 2 had P implanted in a channeling direction; the real damage profile is shallower than in the simulated amorphous sample.

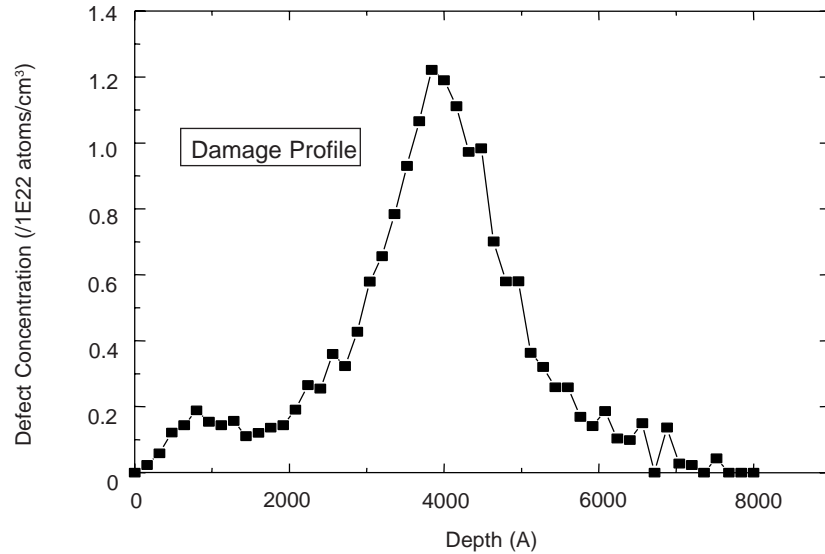
Figure 2. Quantitative Damage Profile

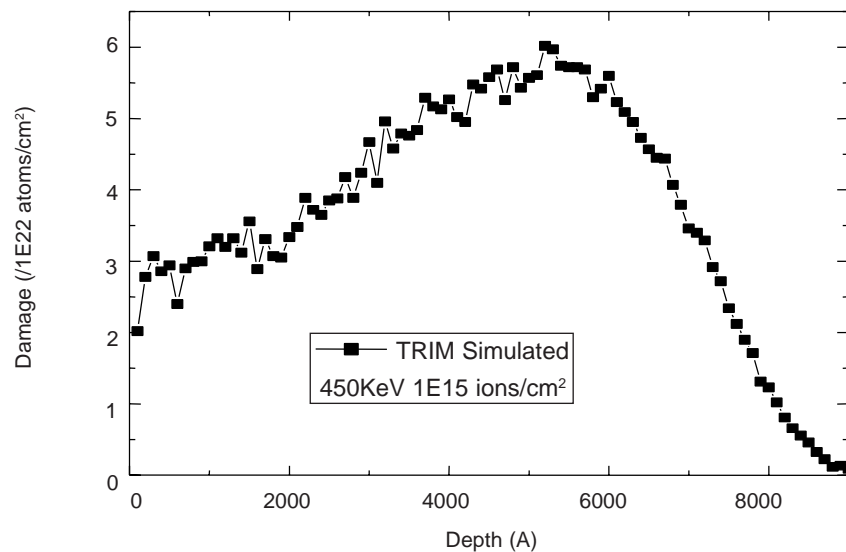
Figure 3. TRIM Simulated Damage Profile in Amorphous Si
