Identification of Buried Carbon Contamination Using Auger and FIB on the 300mm Whole Wafer SMART-Tool™

May 7, 2007 (Version 2.0)

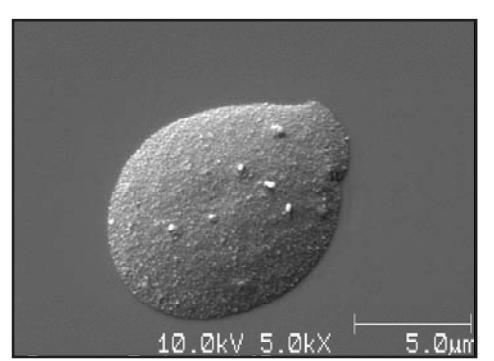
SEM of defect prior to in-situ FIB cross-sectioning.

Inspection after CVD deposition of 500nm of W silicide on a 300mm Si wafer revealed 10 micron "bubble" defects. Auger and EDS analysis of the surface showed no compositional difference relative to the normal W silicide film. An in-situ cross-section of the defect was made with the FIB on the SMART-Tool. Subsequent Auger analysis shows that the defect was C contamination that formed a droplet on the Si wafer surface prior to W silicide deposition. This indicates a contamination from a wet bench operation or an insufficient rinse prior to CVD deposition.

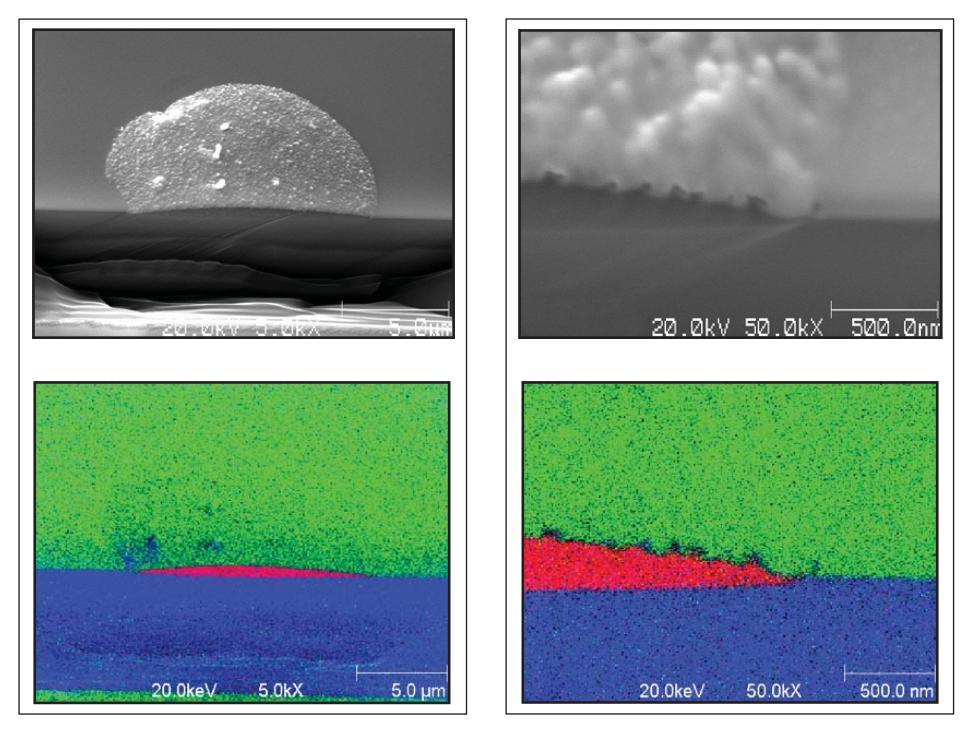
Green = W Red = C Blue = Si

SEM images and Auger maps of the bubble defect after in-situ FIB crosssectioning. The Auger data were acquired without repositioning the sample.

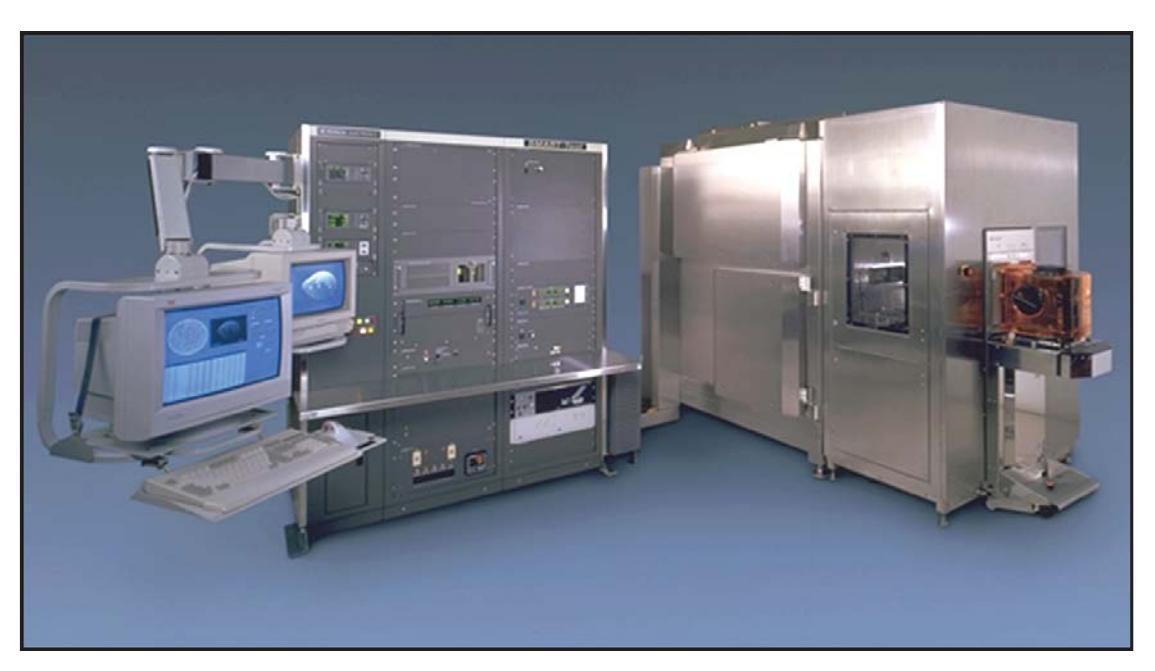
EAG's 300mm whole-wafer Auger, FIB, and EDS SMART-Tool
